# Weekly Construction Report

## Hatchery Creek Design/Build Project

| <b>Time Period:</b> | November 2-8, 2014 | <b>Project No:</b> | 1305 |

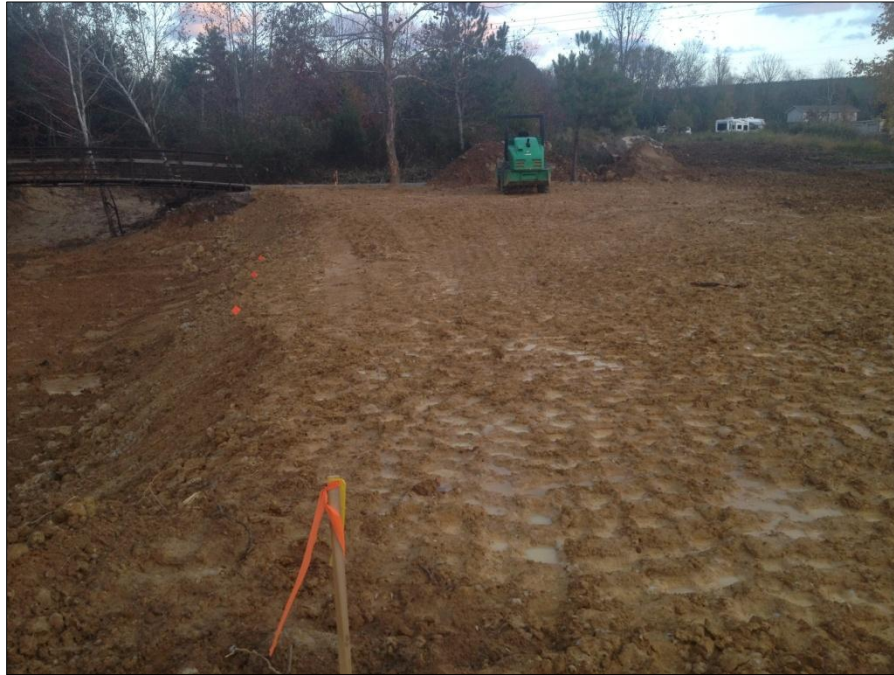
***Compacted clay built up to ~elevation 588' as part of "U"-shaped compacted clay core/groundwater dam at proposed migration barrier location (Photograph was taken looking across future channel and migration barrier location from LT Sta. 105+85).***

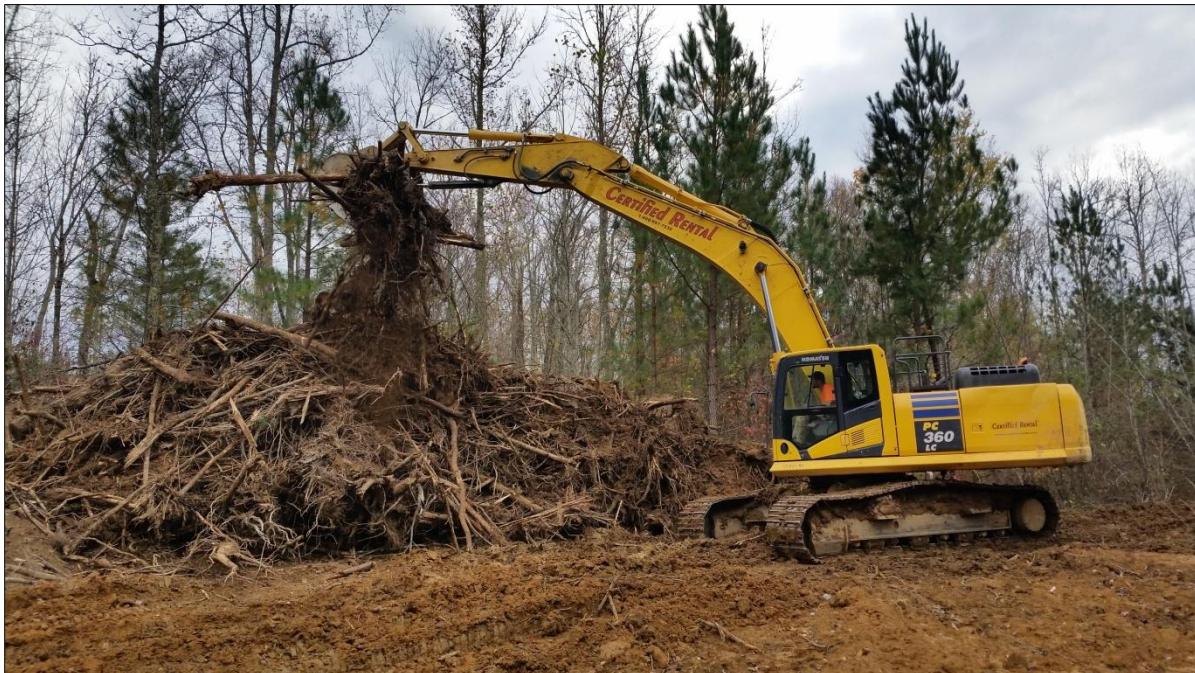
***Moving tree piles from Corps Excavation Site #1. They are being stacked outside of the excavation area, and will be used later in the stream construction.***

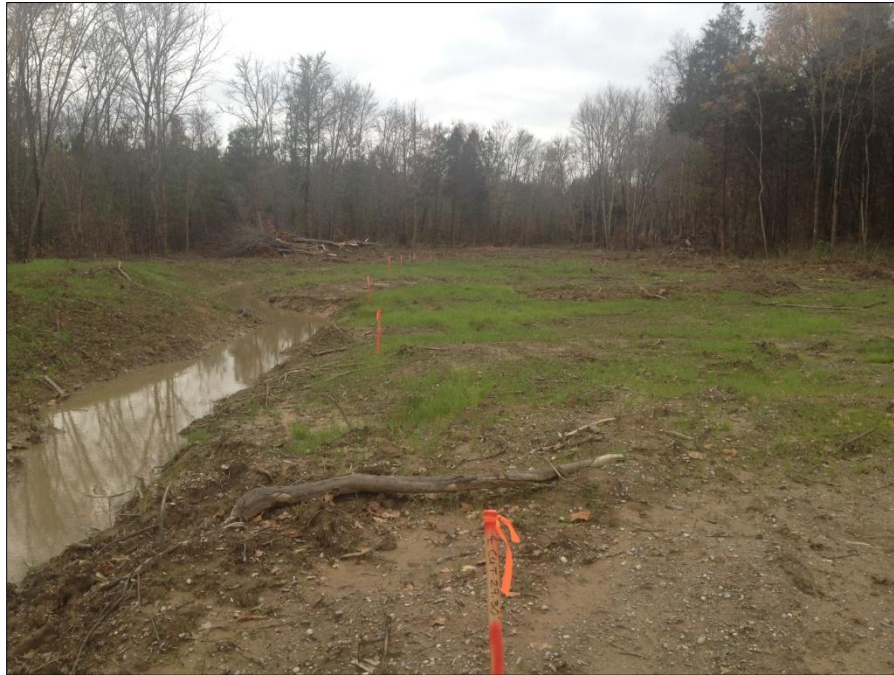
***Remaining trees were cleared on Corps Excavation Site #3. Aspen Construction had the centerline of the step pool reach staked out. The stake in the foreground shows a cut of 29.30'. (Photograph was taken from the gravel road looking upstream at ~Sta.157+50).***

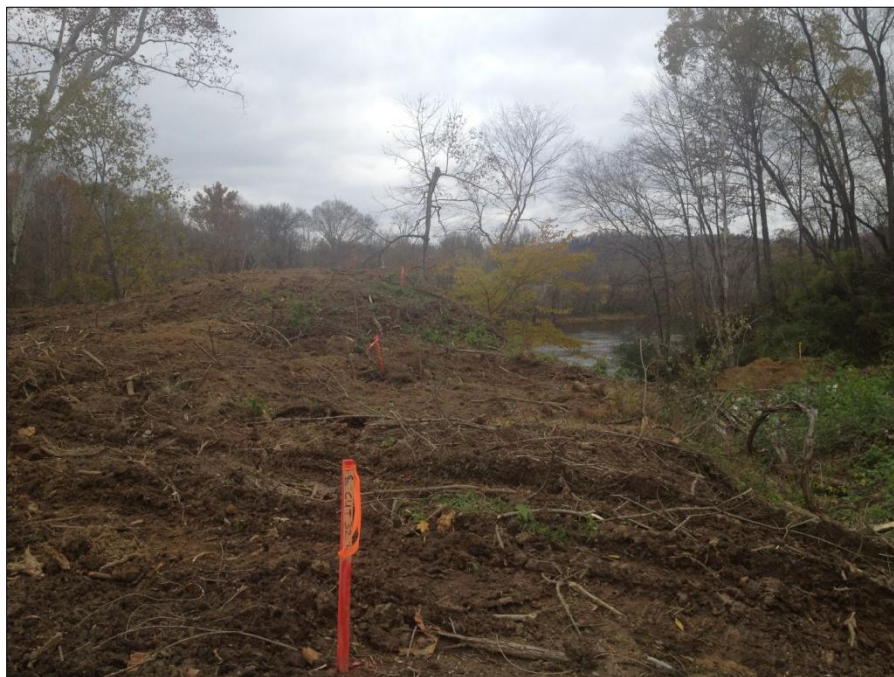
***All but a few trees were cleared along the bank of the Cumberland River on Corps Excavation Site #3. The stake in the foreground shows a 32' cut; the deepest cut is 36' on the knob by the river in the background. (Photograph taken at ~Sta. 158+00 looking downstream).***
